# Abandoning the Cult of the Artifact

## Cultural Landscape Management on the Chilkoot Trail

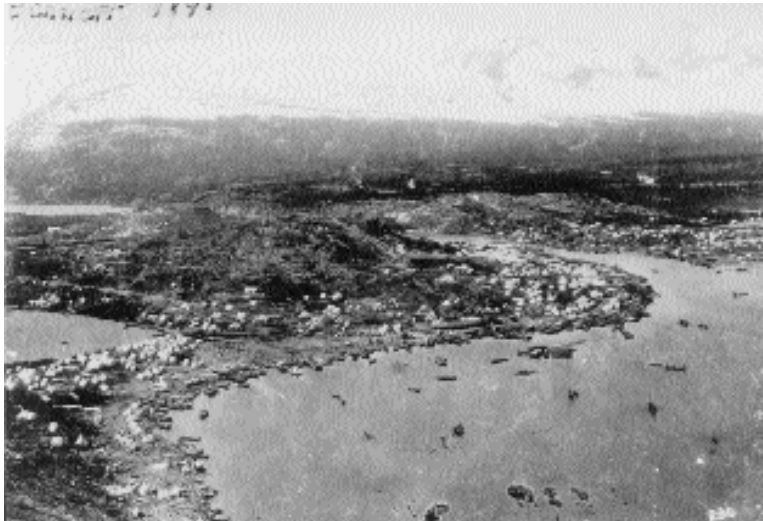
*Bennett City in 1898.*

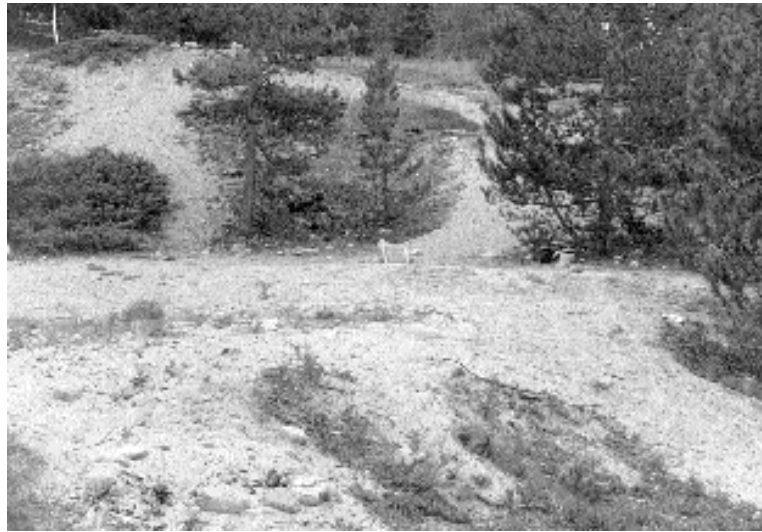
*Eroding paths show the destructiveness of uncontrolled foot traffic. Recent construction of a staircase has directed foot traffic on the slope alleviating this problem.*

Most visitors do not intentionally damage the fragile features, but heavy foot traffic and uncontrolled wandering, in concert with natural processes, can cause severe damage. Throughout Bennett townsite, new paths have been cut into steep slopes and banks as people take shortcuts to the historic trails and main road, move from terrace to terrace, or access the lakeshore. Once such paths are created, they gradually widen with use, vegetation dies and erosion begins.

Site development which focussed on guiding foot traffic, reduced erosive effects. This was accomplished by maintaining the stabilizing vegetation, which helps hold the loose, sandy soil in place. Directing individuals to the historic main road through one access trail reduced some of the problems created by hikers terrace-hopping to reach their preferred camp location. In addition replacing loosened or displaced cobbles in some of the major retaining walls increased overall site stability and protected significant cultural features which would have been impacted by erosion as the retaining walls collapsed.

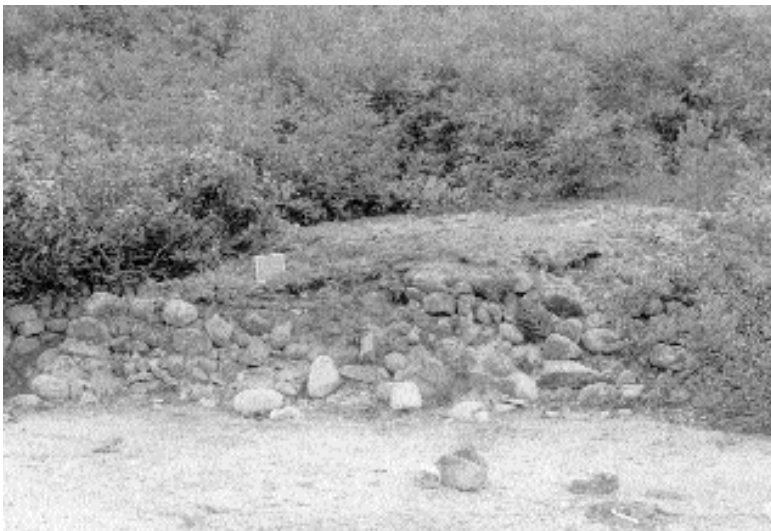
*Cobbles loosened from a historic retaining wall because of visitor traffic. A combination of signs, staircase construction, and cobble replacement have contributed to site stabilisation. Photo by K.Lunn.*

Indiscriminate camping has also been responsible for much damage. Campers securing their tents during windy conditions or building fire rings have often used cobbles from retaining walls and other historic features. This has led to the walls' gradual collapse. As the walls collapse, the terraces slump, destroying the historic landscape.

of site degradation and to measure the effectiveness of the various proposals in stopping or reversing degradation. Observations in 1995 showed that reconstructed retaining walls had assisted in stabilising the hillside. Camping was prohibited on the upper terraces which has reduced the degree to which the edges have crumbled as well as reducing the climbing which had occurred up and down the slopes. Placing staircases at the locations chosen for direct access to the historic main road focussed foot traffic, controlling site circulation and lessening erosion. Paths which were previously used indiscriminately were closed off using vegetation replanting or simply blocked with deadfall. In addition an interpretive program was being developed which was to assist in providing messages to site visitors.
